Manhole Inspection Summary

Manhole # S53A__001MH

Location Address: **3201 pulaski hwy**

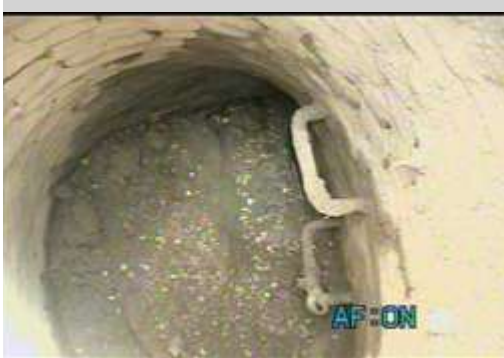
Defect 1

Infiltration: ☐ None ☐ Joint ☐ Cracks ☐ Mortar ☐ Roots ☒ **Wall**

Condition: ☐ Sound ☐ Cracked ☐ Root Intrusion ☐ Deteriorated ☐ Leaks ☒ **Debris**

Count: **4** Missing: **2** ☒ **Corroded**

channel debris, barrel infiltration, corroded steps

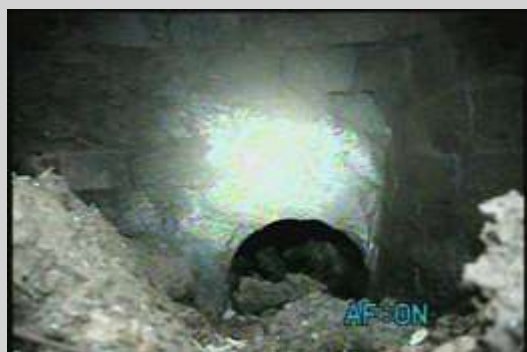
12 O'Clock Outflow

8 in. Circular Gravity Sewer
Pipe Out @ 12 O'Clock

Deposits: ☐ None ☐ Mud ☐ Sludge ☒ **Debris** ☐ Grease

Silt Depth: **2** (in.) Deposits Extent: **Medium**
